April 18, 2013

Subject: Sugar Creek Scrap Site Assessment Report
Terre Haute, Vigo County, Indiana
Technical Direction Document No.: S05-0001-1302-008
WESTON START Contract No.: EP-S5-06-04
Document Control No.: 2096-2A-BDCD

**SITE ASSESSMENT REPORT
FOR THE
SUGAR CREEK SCRAP SITE
TERRE HAUTE, VIGO COUNTY, INDIANA
SITE ID NO. C5R4**

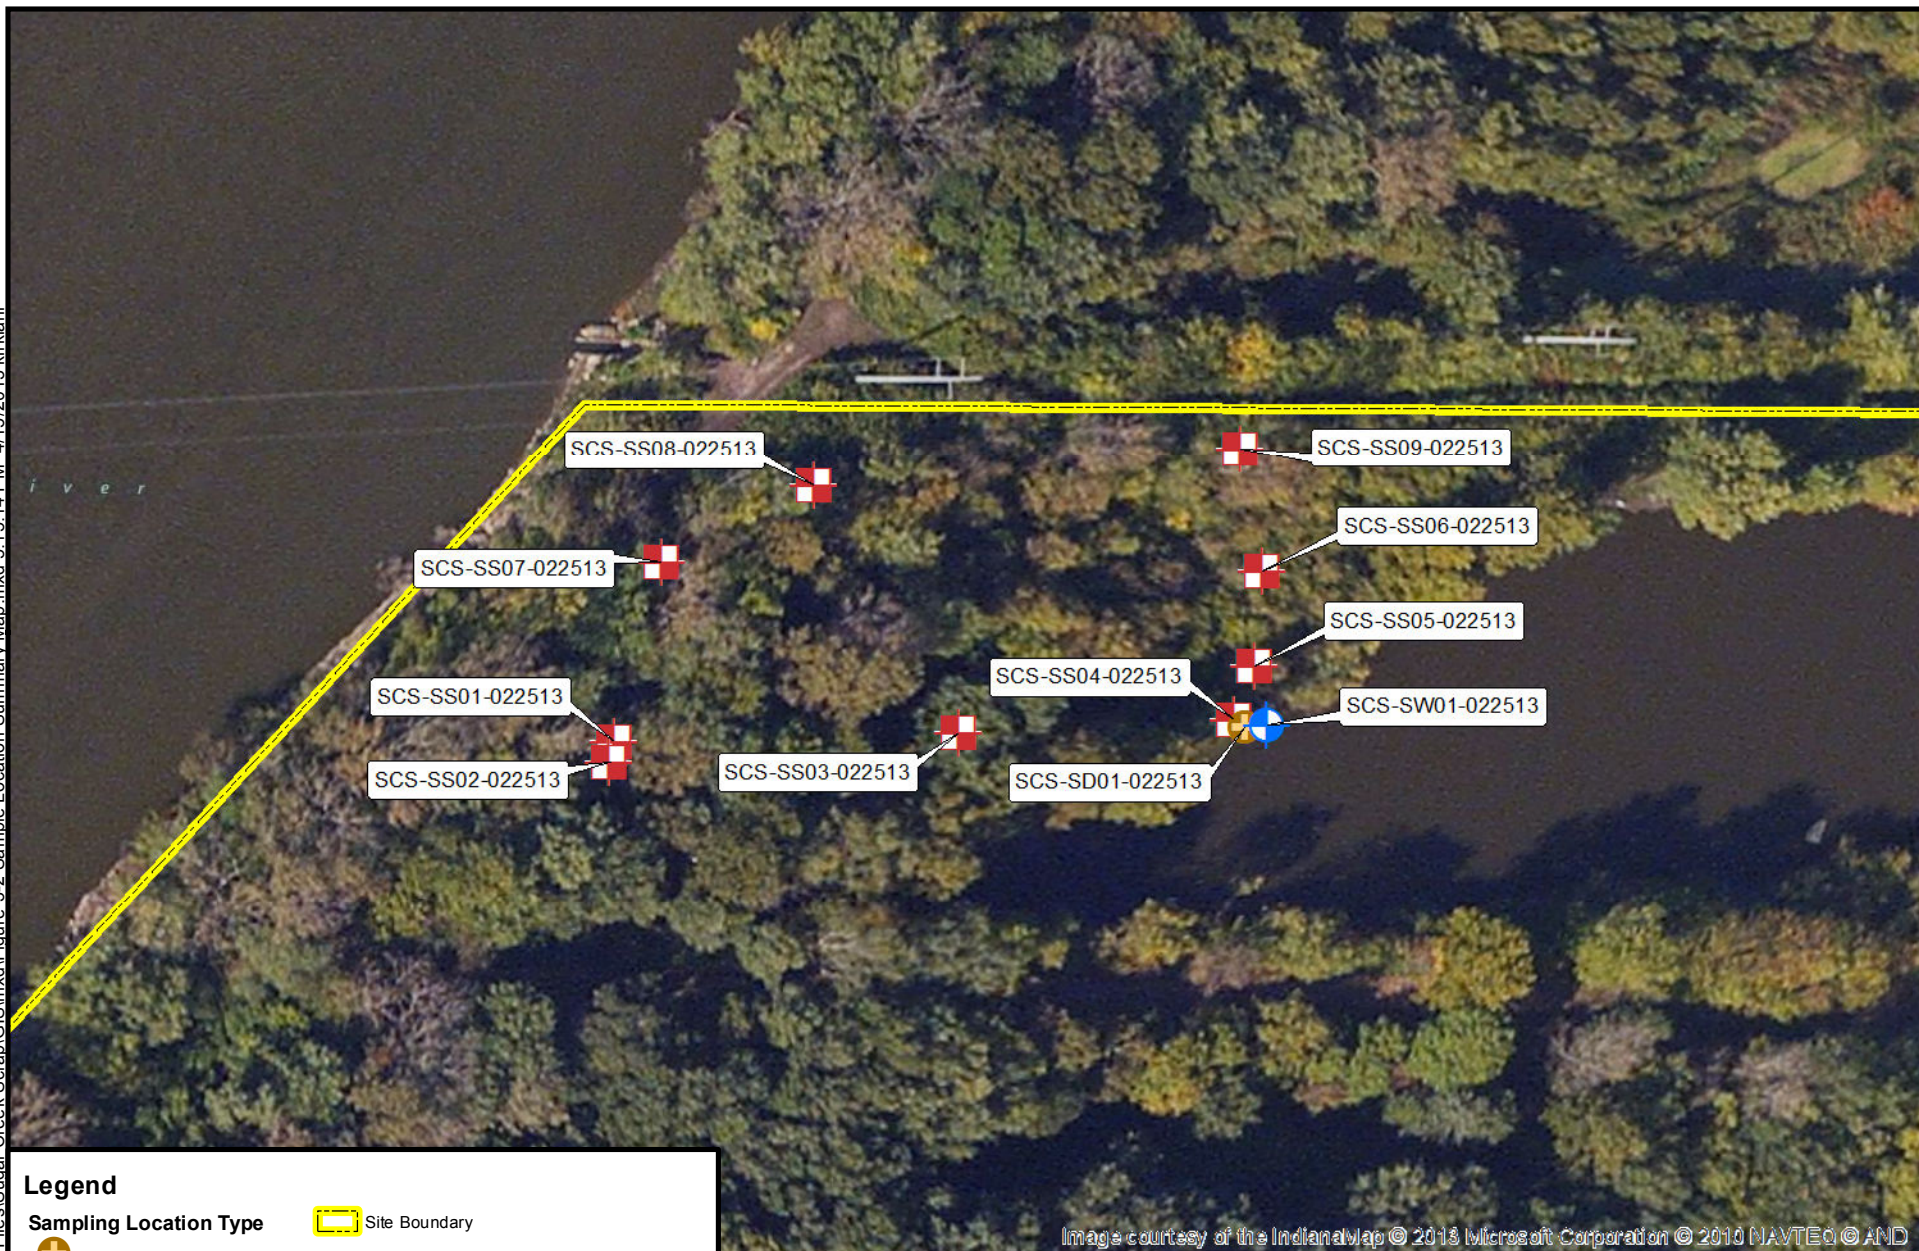
Figure 3-2
Sample Location Summary Map
Sugar Creek Scrap Site
Terre Haute, Vigo County, Indiana

collected using a disposable poly scoops into 8-ounce, glass sample jars. Each sample is described in the following paragraphs. **Figure 3-2** shows the sampling location map. The maximum XRF screening values are reported from either the initial sample location screening or the material collected in the aluminum pan prior to being placed in the sampling jar.

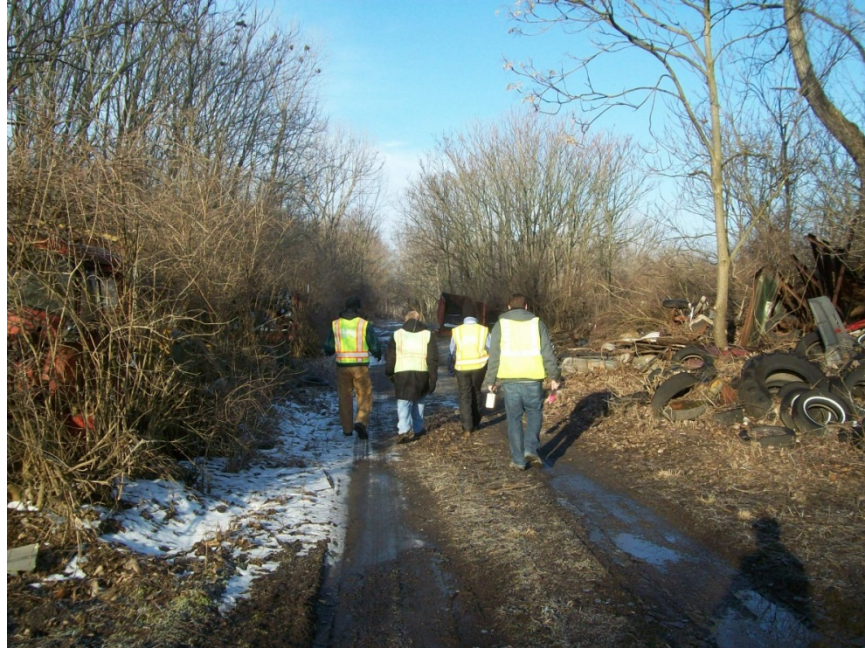
Photograph No.: 1

Subject: Scrap metal, yellow-iron, and machinery present onsite in the encroachment area along the levy

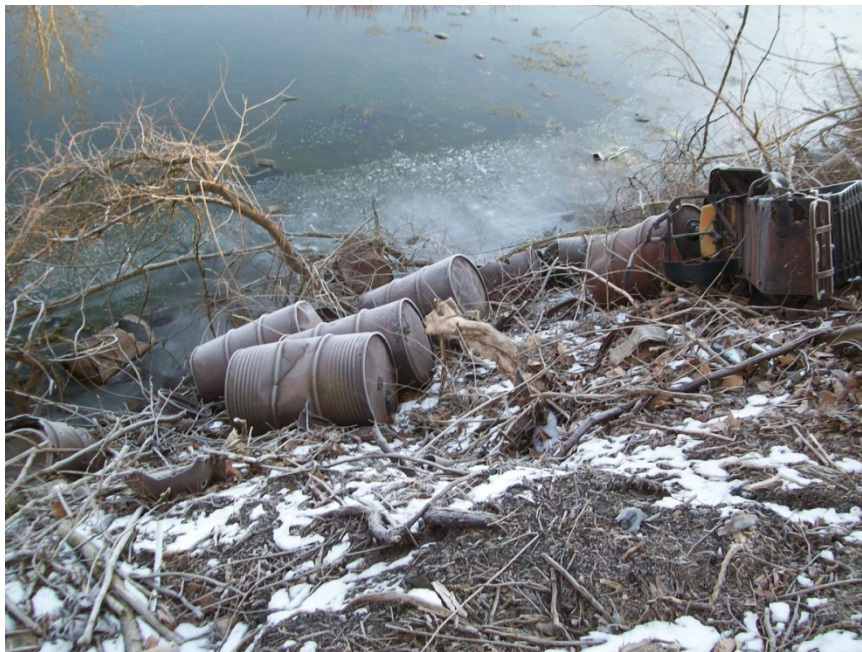
Photograph No.: 4

The north low land area includes a sediment pond and a wooded area. Clearing and grubbing activities were evident in the elevated area between the sediment pond and the banks of the Wabash River. However, the elevated area was still within the overall low land area. This elevated area was approximately 6 to 12 feet (ft) above the water surface of the sediment pond. Approximately 150 55-gallon drums were observed on the banks of the sediment pond, within the sediment pond water, and throughout the surrounding area. Many of the drums found along the levies were found to be empty. However, the grade of the south bank of the sediment pond was too steep to allow access to approximately 25 55-gallon drums (see **Appendix A, Photograph Number 4**).

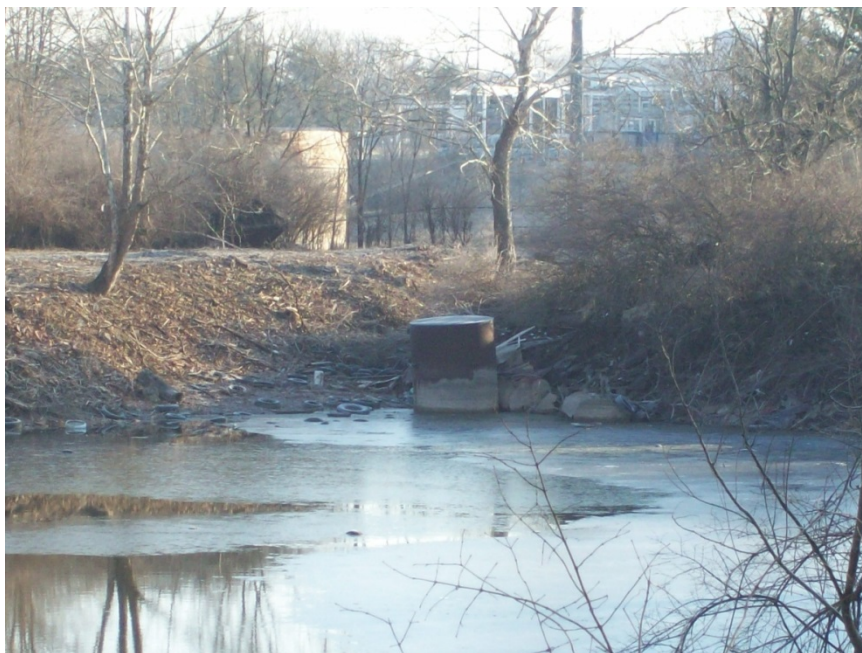
Photograph No.: 5

Subject: Abandoned above ground storage tank in northeast corner of the sediment pond
